# CHASE BAG CSM Site Summary

Oregon DEQ ECSI #: 2424

3720 NW Yeon Ave. DEQ Site Mgr: No PM Latitude: 45.5484° Longitude: -122.7181°

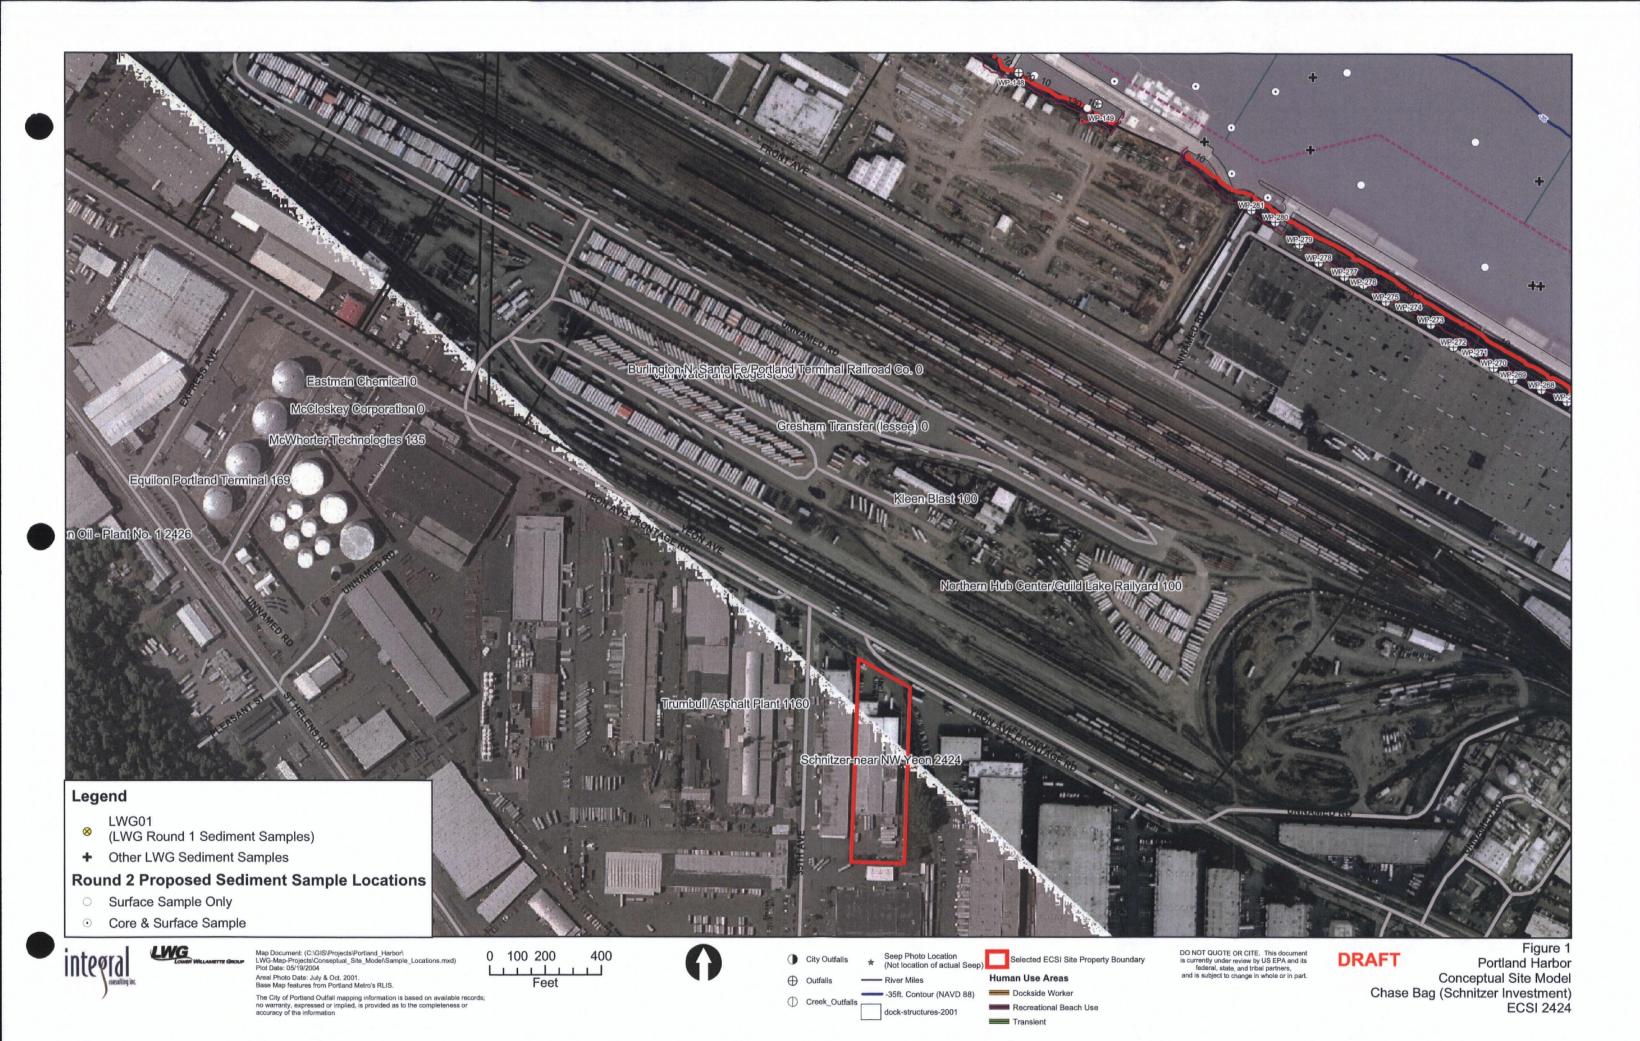
Figure 1. Site Features

As shown in Figure 1, the 2.84-acre former Chase Bag property is located in the Guild Lakes area, approximately 0.4 mile south of the Willamette (RM 9.2). The currently inactive site is located in a heavy industrial and warehousing area. The closest residence is 0.28 mile to the southeast. A separate Schnitzer Investment Corp. parcel lies between the site and NW 35<sup>th</sup> Street, Terminal Transfer and a Burlington Northern railroad spur are located to the east, a Hill Investment Co. warehouse is located to the south, the Trumbull Asphalt site is located to the west, and Burlington Northern's Lake Yard rail yard is located to the north (DEQ 2004).

An 80,520-square-foot structure occupies most of the property. It is mostly paved. An underground storage tank fill pipe and vent pipe were observed by DEQ in the southeast corner of the site. An aboveground storage tank rack was also observed along edge of the site. Fencing surrounds most of the site, except along the southeast property line (DEQ 2004).
